# Manhole Inspection Summary

Manhole # S3100\_007MH

Insp Date: **4/25/07 10:48 AM**

**Location** Address: **330 HAMDEN AVE**

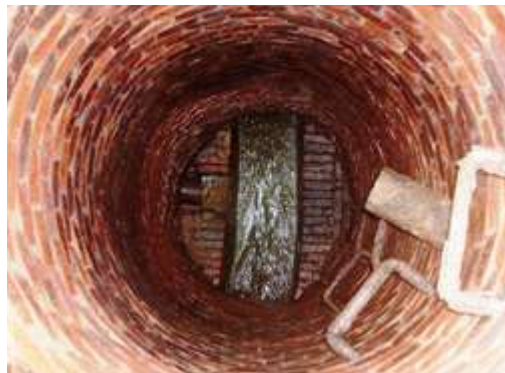
Top View

Corroded steps. Bench debris.

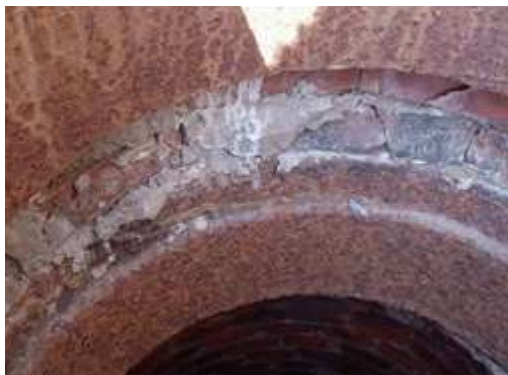
Defect

Adjustment deterioration and infiltration - other side.

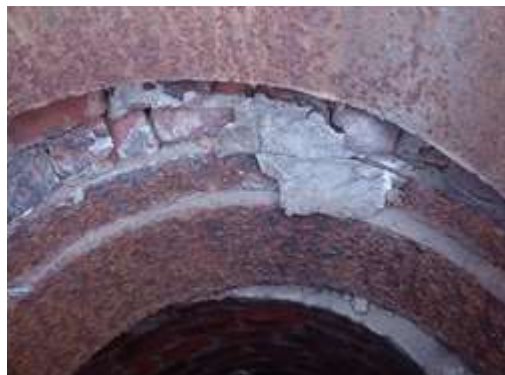
Defect

Adjustment deterioration, loose brick and infiltration.

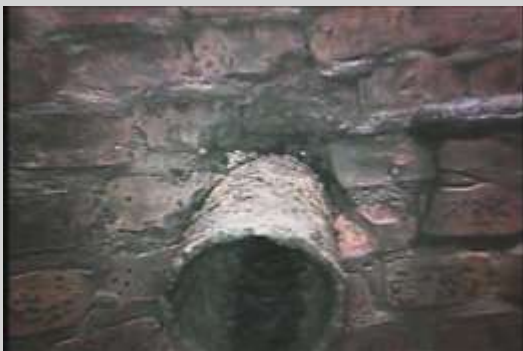
### 4 in. Circular Gravity Sewer Pipe In @ 4 O'Clock

Infiltration: **Evidence** Pipe Seal Cond: **Broken**
